7.3.1 Main Street at Interstate 5

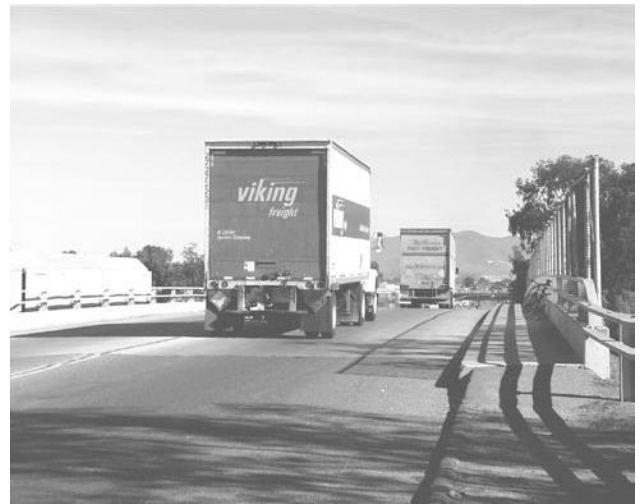
Main Street at I-5: View eastbound on south side of bridge

The intersection of Main Street and Interstate 5 is in far southwest Chula Vista. The intersection itself is on both City of Chula Vista and City of San Diego property, as well as falling within Caltrans right-of-way. It is a half cloverleaf interchange with on- and off-ramps for both directions all connecting with Main Street on its north side.

There were no reported crashes involving bicycles at this intersection since 1999 and no bikeway facility crosses the bridge, but there is a Class 2 lane passing directly to the west on Bay Boulevard in a north-south axis from the City of San Diego connecting to the existing Class 1 portion of the Bayshore Bikeway to Imperial Beach. Main Street itself does not have a bikeway facility.

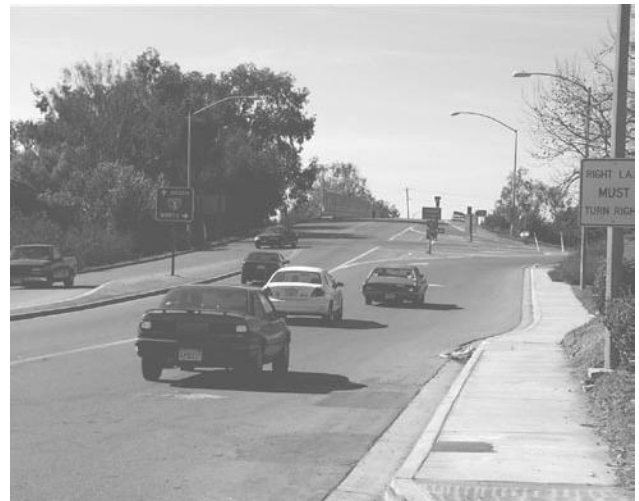
Main Street at I-5: View westbound approaching bridge

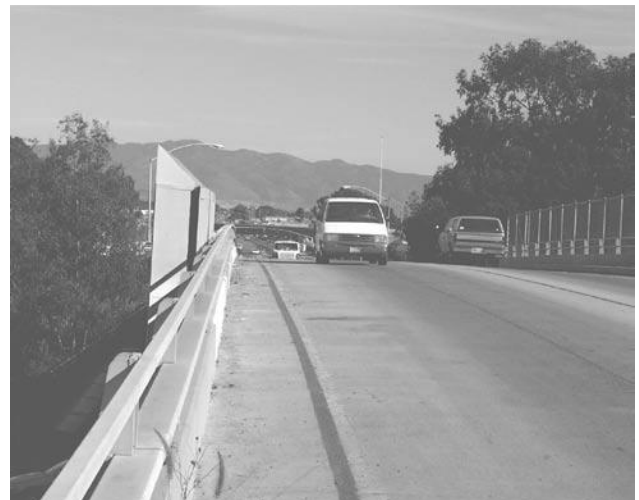
Main Street at I-5: View eastbound on north side of bridge
